# Horrane Fault

January 2019

**The Horrane Fault is a sub-surface crack through rock layers, caused by deep-earth pressures over many millions of years. While faults occur across Arrow's Surat Basin tenure, the Horrane Fault is the largest.**

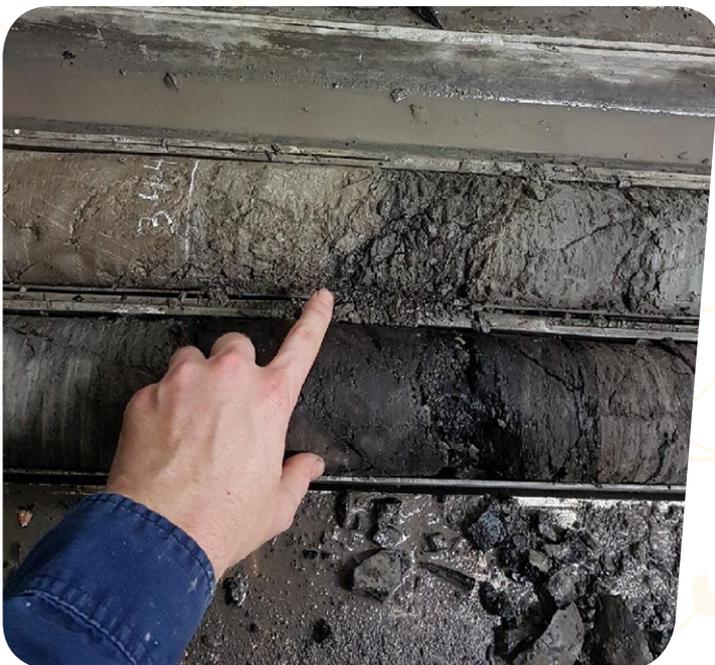
Plainview 34 core showing the fault zone and 'fault gouge'

- In 2017, Arrow drilled the Plainview 34 core hole, deliberately intersecting the fault (the first-known deliberate intersection of a fault in the Surat). The core (a cylinder of rock cut out of the ground) showed a fault zone of about 2.5m of highly-fractured rock with a 'fault gouge' of fine, clayey material which is quite impermeable.

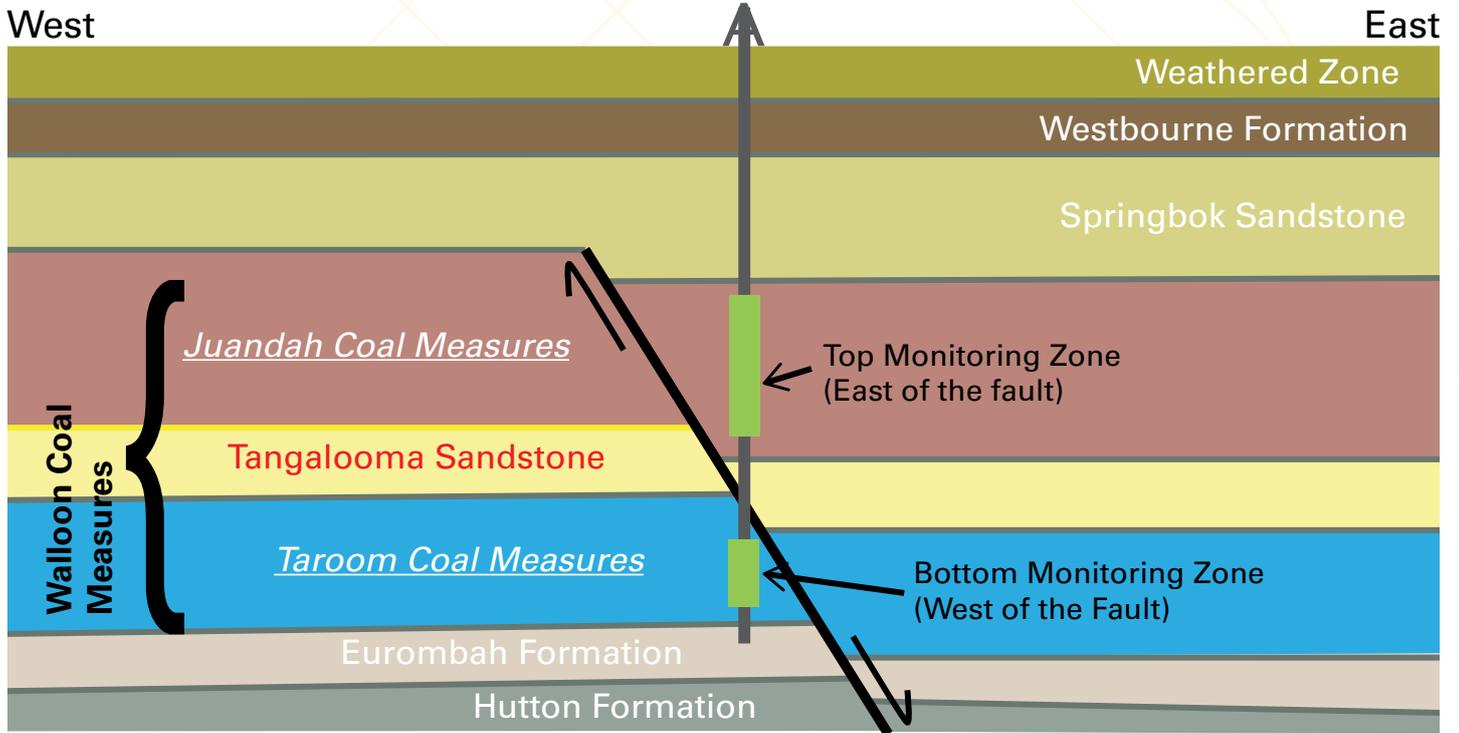
\*Not to scale

Plainview 34 well schematic

- The fault was directly tested in the Plainview 34 core hole by isolating the fault zone with a series of seals, and pumping water at high pressure into a permeable coal seam closely above the fault. Pressure gauges around the fault showed no increase in pressure (which would have been expected if fluids could flow along the fault). This suggests that there are no leaks along the fault.

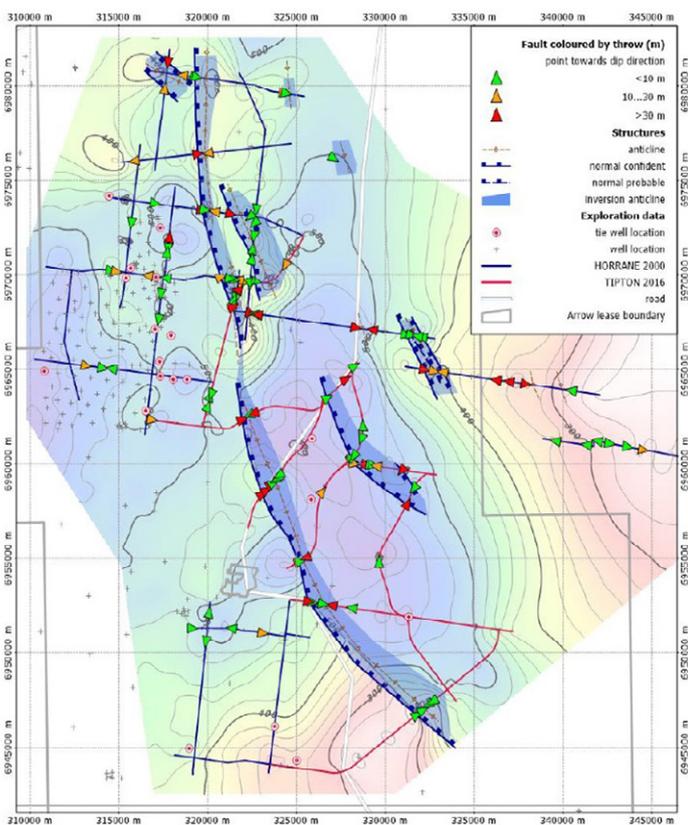
Structural interpretation of the Tipton and Horraine seismic surveys. The background image and contours refer to the converted depth of the Eurombah horizon.

- In 2017, Arrow's Tipton seismic survey further defined the fault's location, building on seismic information collected back in 2000 (one of Arrow's first seismic mapping programs).
